Clinical longevity of ceramic laminate veneers bonded to teeth with and without existing composite restorations up to 40 months

Gresnigt, Marco M M ; Kalk, Warner ; Özcan, Mutlu

Journal Article

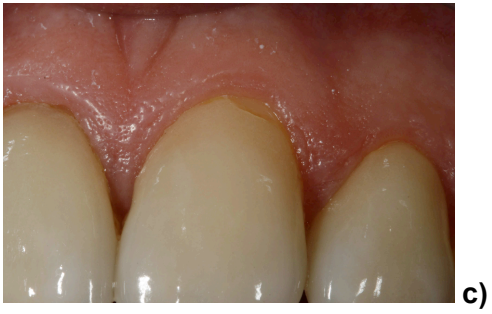
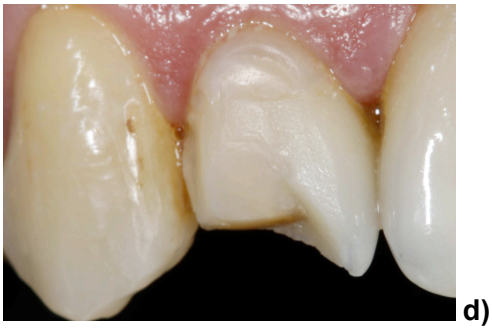
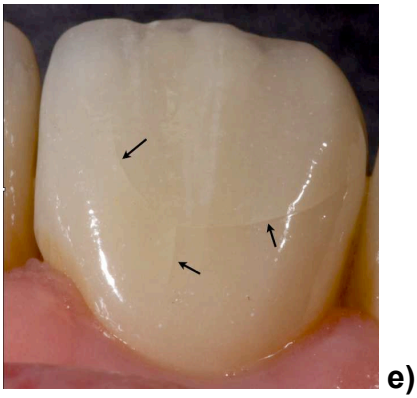
Figs 2a-e Representative photos of some failures **a)** adhesively debonded laminate from tooth 12. Note that no resin cement was bonded on the tooth that had small existing resin composites on mesial and distal sides, **b)** cohesive chipping of the laminate at the incisal edge of the ceramic on tooth 23 that was bonded to tooth only, **c)** cervical fractures of the laminate veneer on tooth 21. It was bonded to big existing composite restorations on the mesial and distal sides of the tooth. The detached fragment was adhesively debonded with no resin cement bonded on the tooth, **d)** fracture of the laminate veneer on tooth 12 due to trauma that failed adhesively between the tooth and the luting cement and partially cohesively within the ceramic. Part of the ceramic laminate was left adhered where an existing composite was present and the other part was debonded from the dentin surface, **e)** multiple cracklines visible before fracture on laminate veneer bonded to tooth 11 without any existing restorations

A total of 5 absolute failures were observed in the form of debonding (n=1) (Fig. 2a), chipping (n=1) (Fig. 2b) and fractures (n=3) (Fig. 2c-e). Three months after cementation, one laminate debonded with an adhesive failure between the tooth and the luting cement. On both mesial and distal sides of the tooth (12)

there were small existing composite restorations. After cleaning the cementation surface, the debonded veneer was re-cemented using the same adhesive protocol (Table 2a-b).

The chipping was a cohesive failure in the ceramic at the incisal edge that occurred 18 months after cementation (Fig. 2b). The laminate veneer was bonded onto tooth 23 that had no existing restorations. It was replaced with a new laminate veneer of the same kind. Eight months after placement, one of the fractures occurred at the cervical area of a laminate veneer on tooth 21 that had big existing composite restorations on the mesial and distal sides (Fig. 2c). The detached fragment was debonded in an adhesive fashion with no luting cement bonded to dentin. Patient reported that he bit on a cherry seed. The second laminate fracture was experienced on tooth 12, 38 months after cementation (Fig. 2d). It was fractured into two pieces. While one half was left attached on an existing composite restoration on the mesial side of the tooth, the other half was debonded adhesively from the dentin surface. The third laminate fracture presented itself with crack lines on tooth 11 with an existing restoration at the mesial side, 4 months after cementation (Fig. 2e). All 5 failures were experienced in laminate veneers bonded to vital teeth.
